Experience with Be at JET

J P Coad

IAEA meeting 26-28 Sept 2012

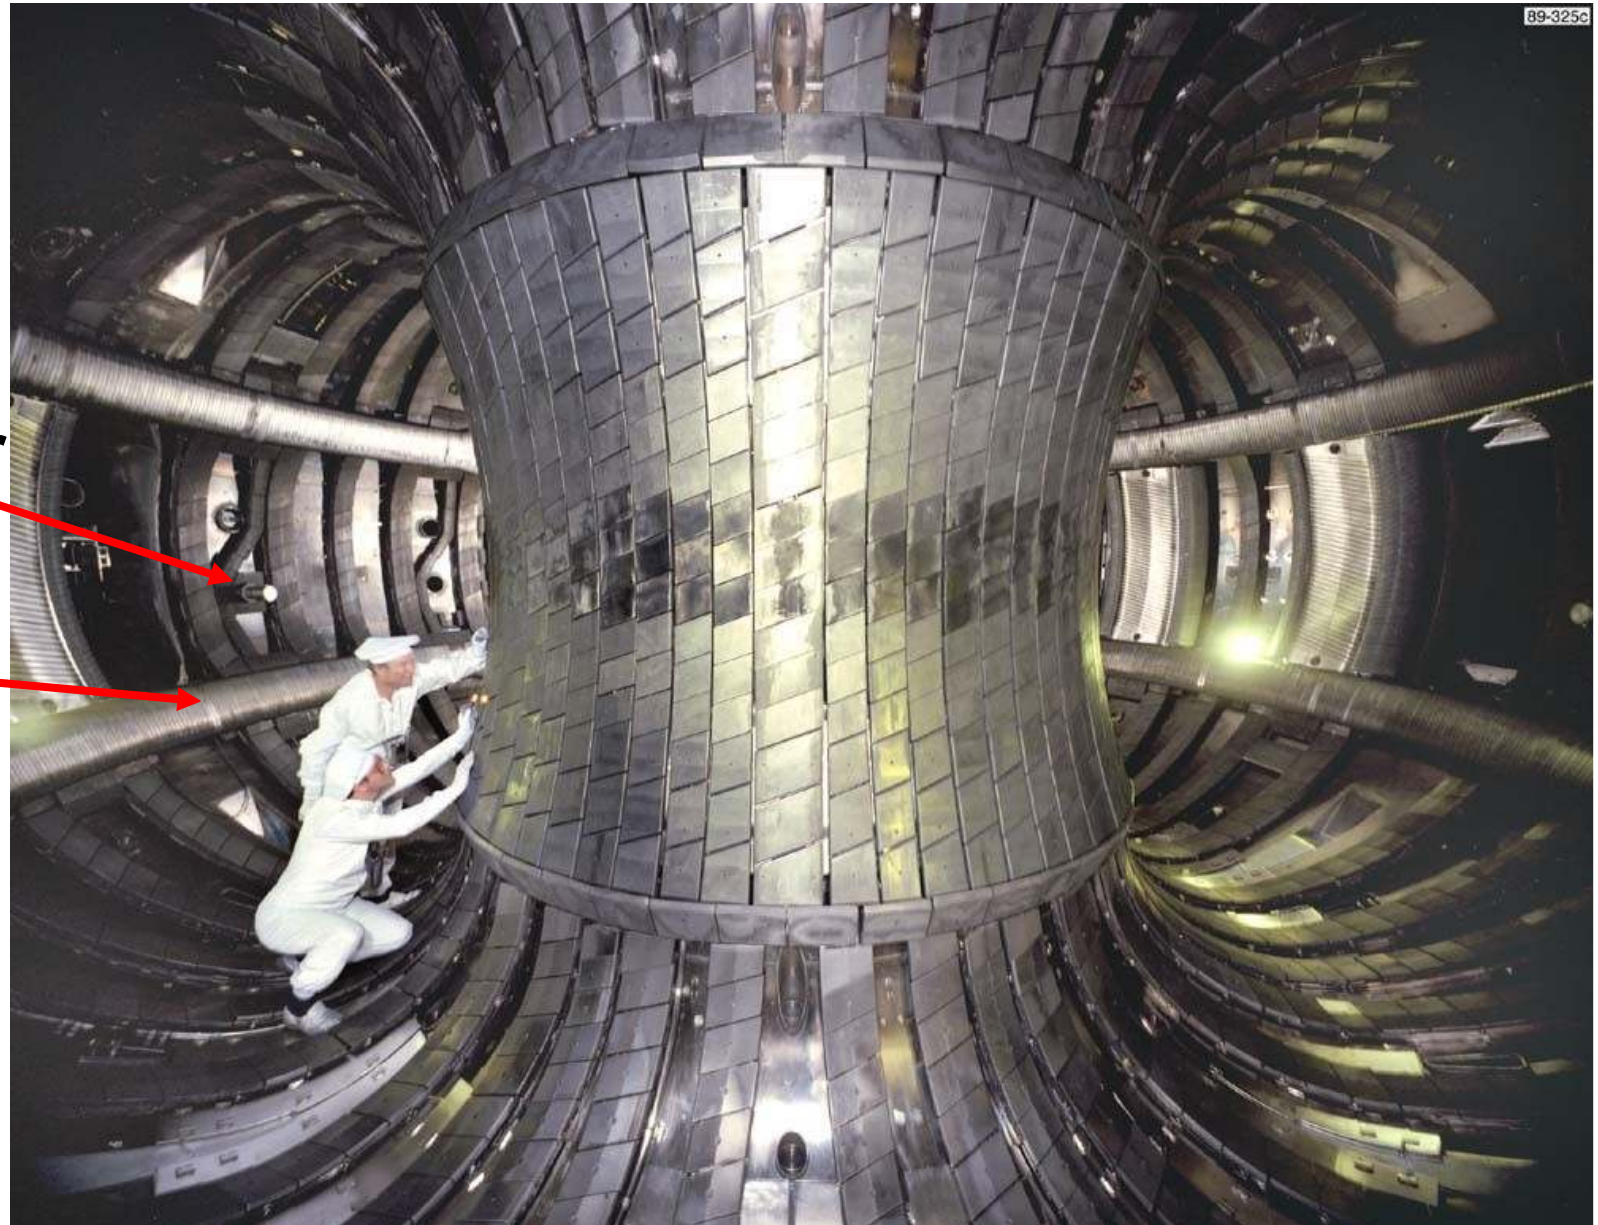
Belt limiter

Belt limiters were not successful due to edge erosion (C) and melting (Be) that limited power handling

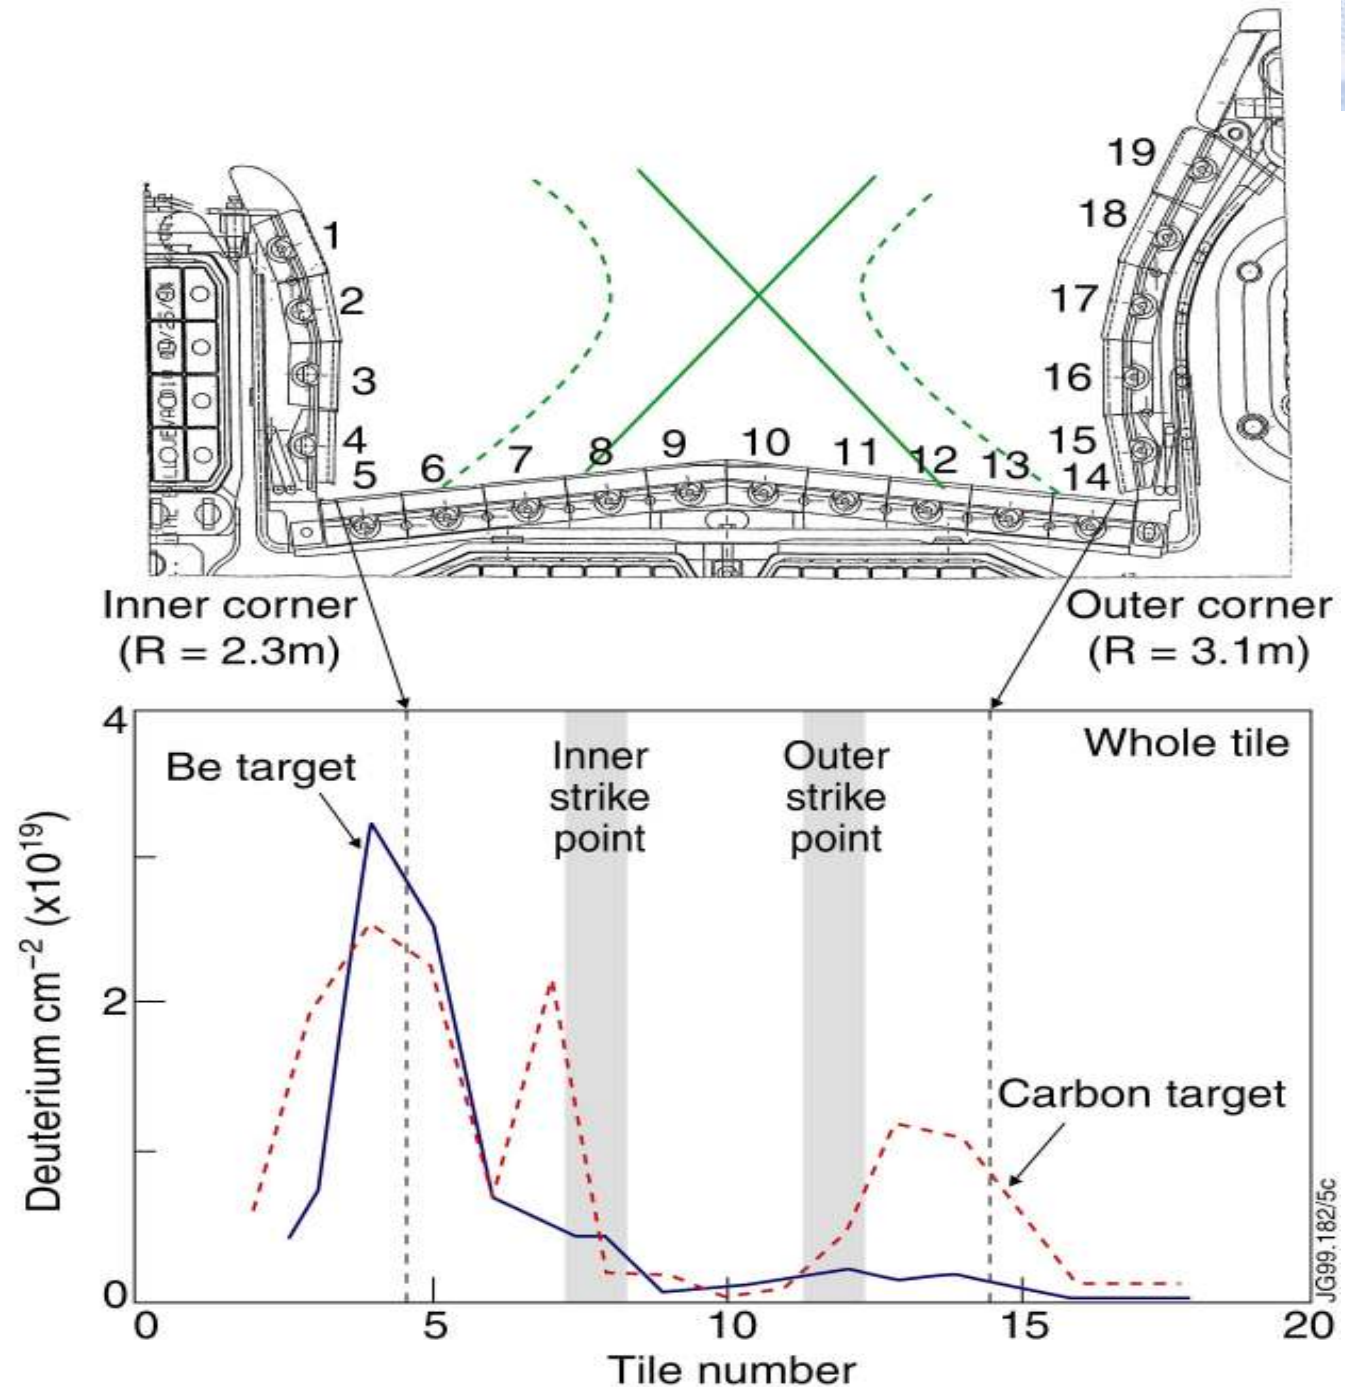
Deposition at the JET Mk I divertor

Proved that material deposited in the divertor was eroded from the main chamber. Melt experiment performed on the Be divertor

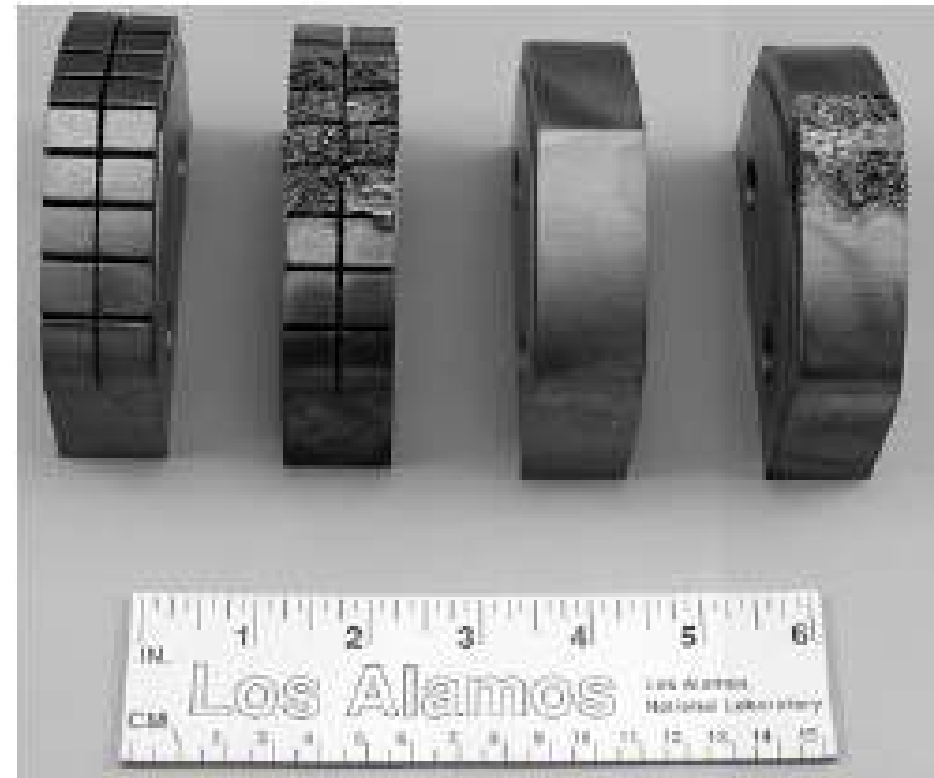
Beryllium Plasma Spray - Repair

Indication of the possibility to repair the damaged components:

- PS applied on damaged (melted, cracked, contaminated surface)
- Coatings 1 mm to 1.5 mm thick with a porosity level on the order of 7-12% were deposited
- 5 MW/m^2 for 10 s/60 off pulses applied:
- Survived 500 cycles before cracking was observed, after 680 cycles – hot spots, test was terminated

Note: PS coating on the undamaged Be tiles survived only 10 cycles at 5 MW/m^2

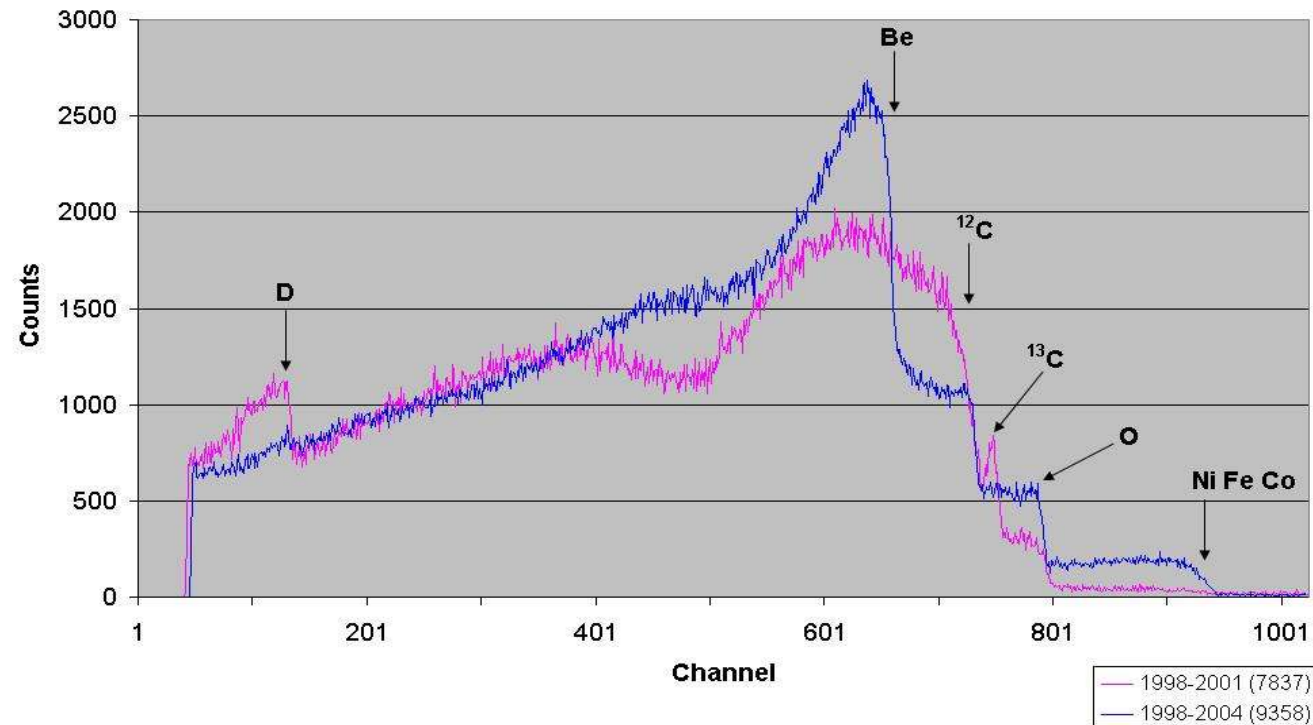
RBS of tile 3 removed in 2004 compared with one from 2001

- Much more Be and other metals in 2004
- Much more D and ^{13}C in 2001 (^{13}C comes from injection of methane at top of vessel during last pulses of the campaign)

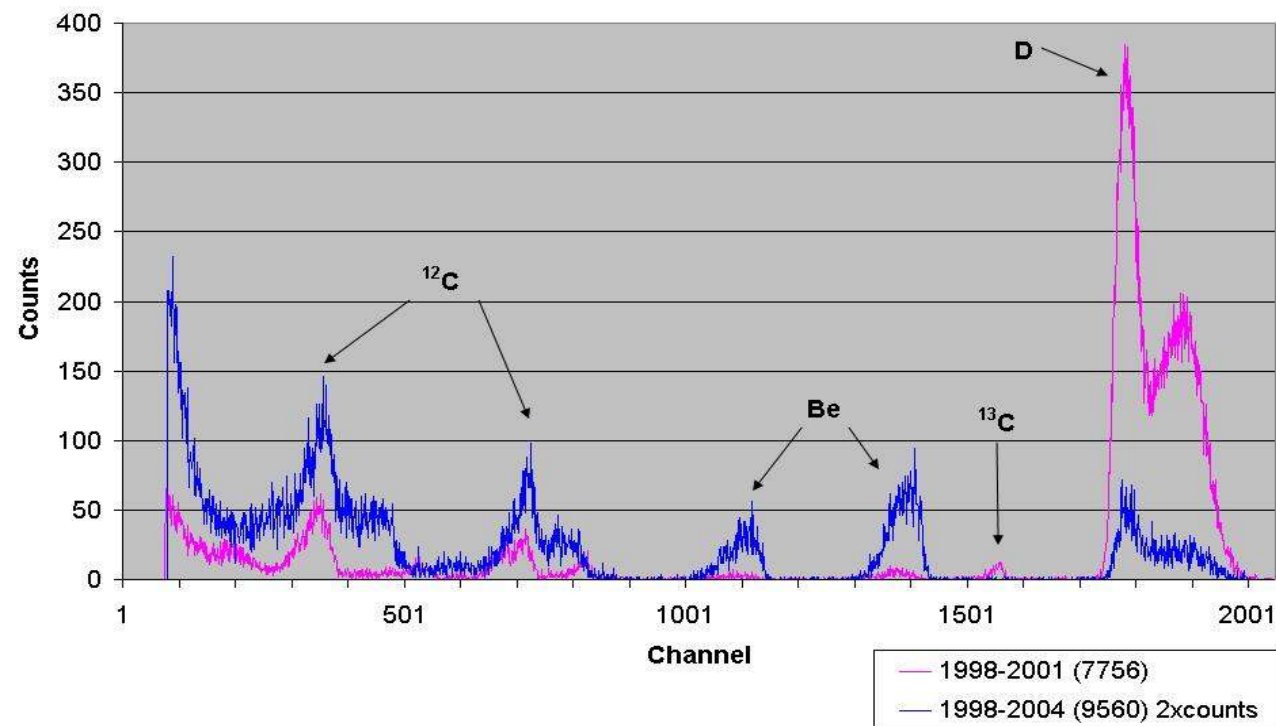
NRA of tile 3 removed in 2004 compared with one from 2001

- Much more Be in 2004
- Much more D in 2001 and ^{13}C also detectable

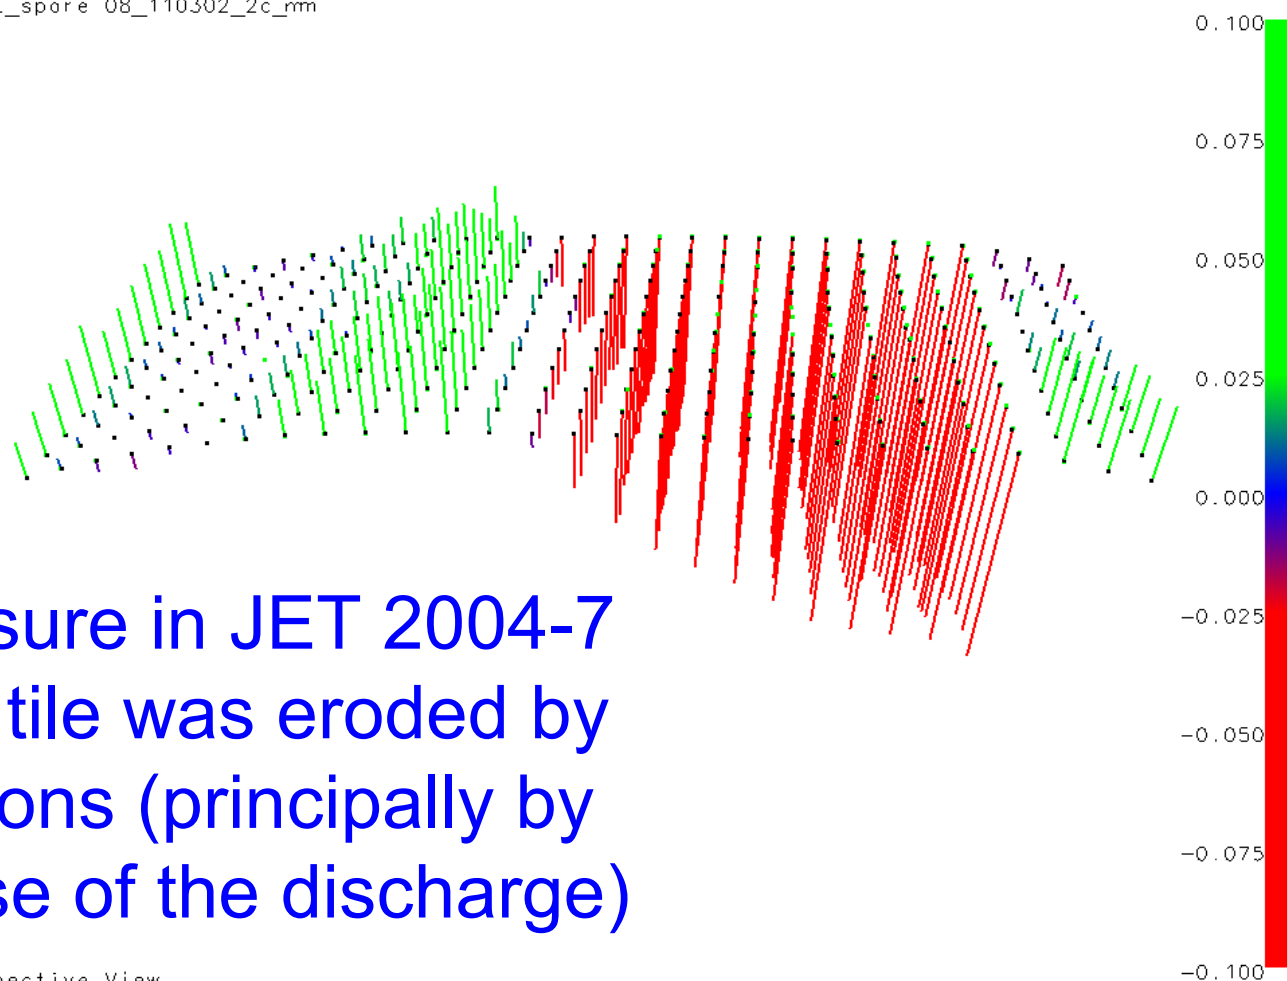
Surface profile for tile G3B

After exposure in JET 2004-7
part of the tile was eroded by
~200 microns (principally by
limiter phase of the discharge)
